INSPECTION REPORT

DATE OF INSPECTION: August 12, 2020

PERMITTEE - MINE: Coteau Properties Company - Freedom Mine

PERMITS INSPECTED: Portions of Permits NACT-9501 and NACT-0201

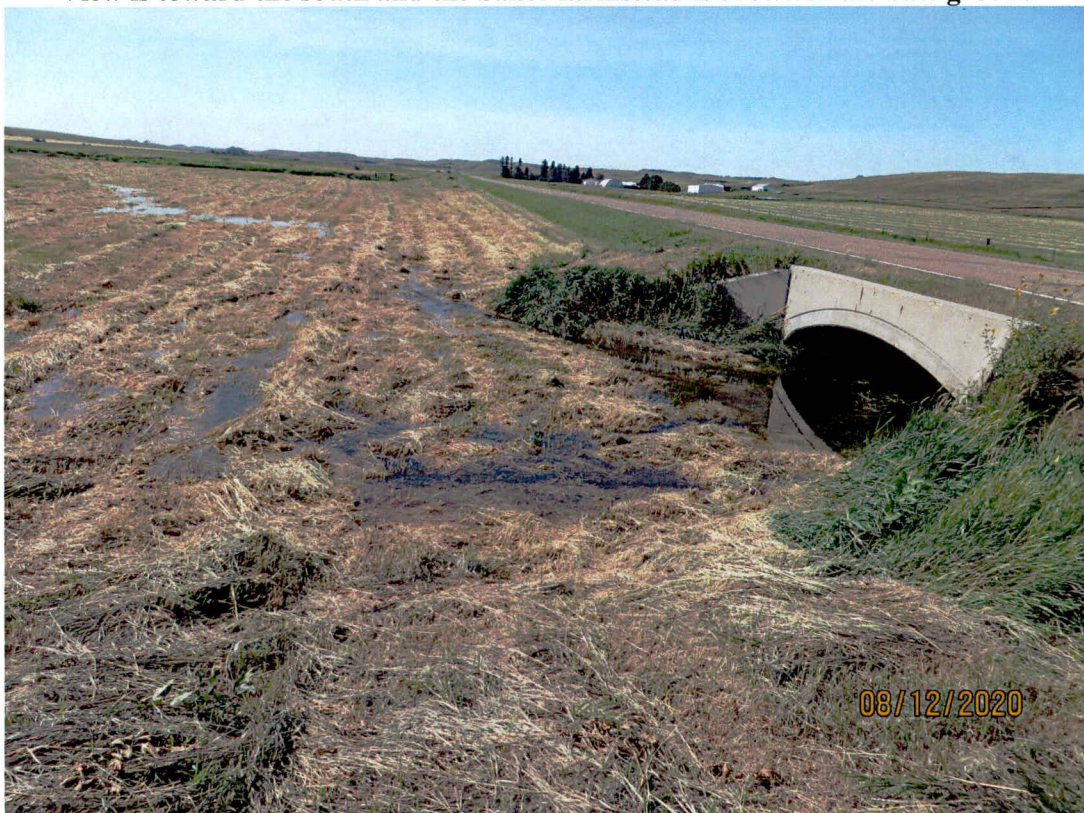
Figure 1.

and incised into the underlying alluvium. The hayfield was saturated with visible areas of standing water to the point that Mr. Gustafson was unable to bale hay within those areas of the field. It appeared the affected area was about two acres in size. Ms. Sailer indicated that similar wet field conditions were also located across County Road 15 to the west in hayland within the NE1/4 of Section 28 bordering the creek; however, the creek channel is significantly more contained within its banks in the NE1/4 of Section 28 and we did not inspect that particular field because the main area of Ms. Sailer's concern/complaint was in the NW1/4 of Section 27.

**View of a portion of the flooded hayfield in the NW1/4 of Section 27
View is toward the south and the Sailer farmstead is shown in the background**

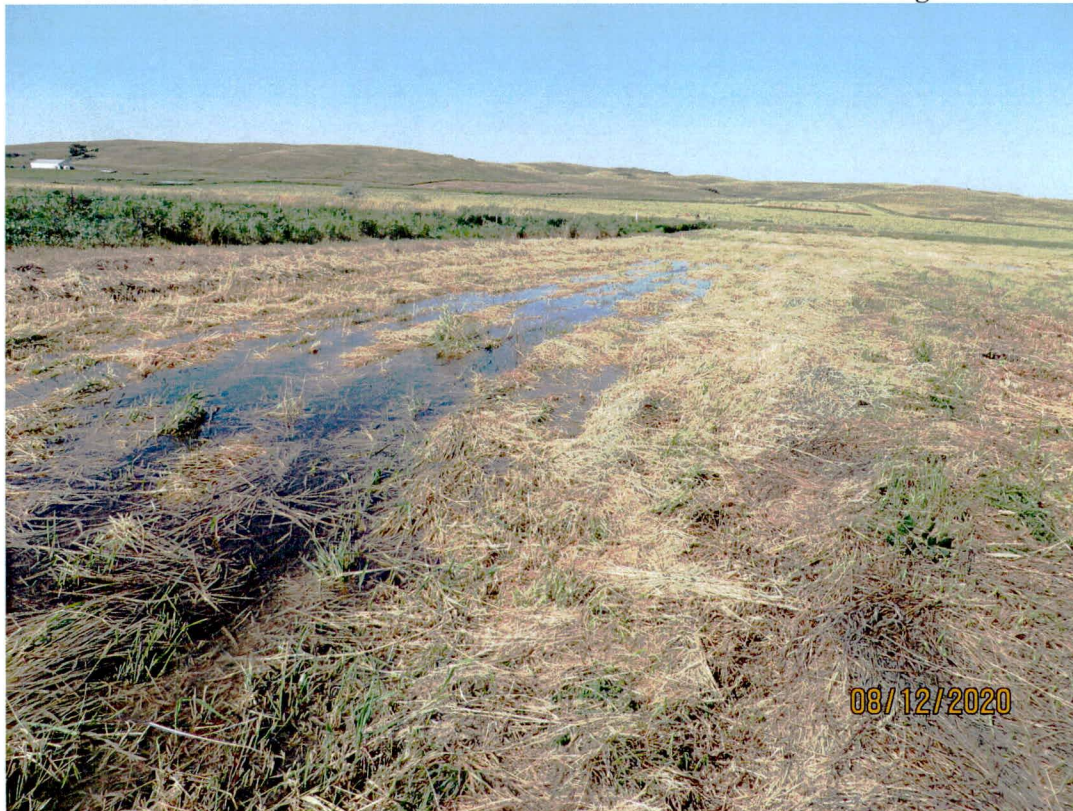
Figure 2 shows a constructed diversion that runs in an east-to-west direction along the south side of the NW1/4 of Section 27. The diversion was apparently constructed years ago to direct and contain stream flow coming from the east, but also converges with the creek coming from the south.

Figure 2
Constructed diversion along south side of the Sailer hayfield in the NW1/4 of Section 27
View is toward the southwest with the Sailer farmstead in the background
